## Bankers Trust

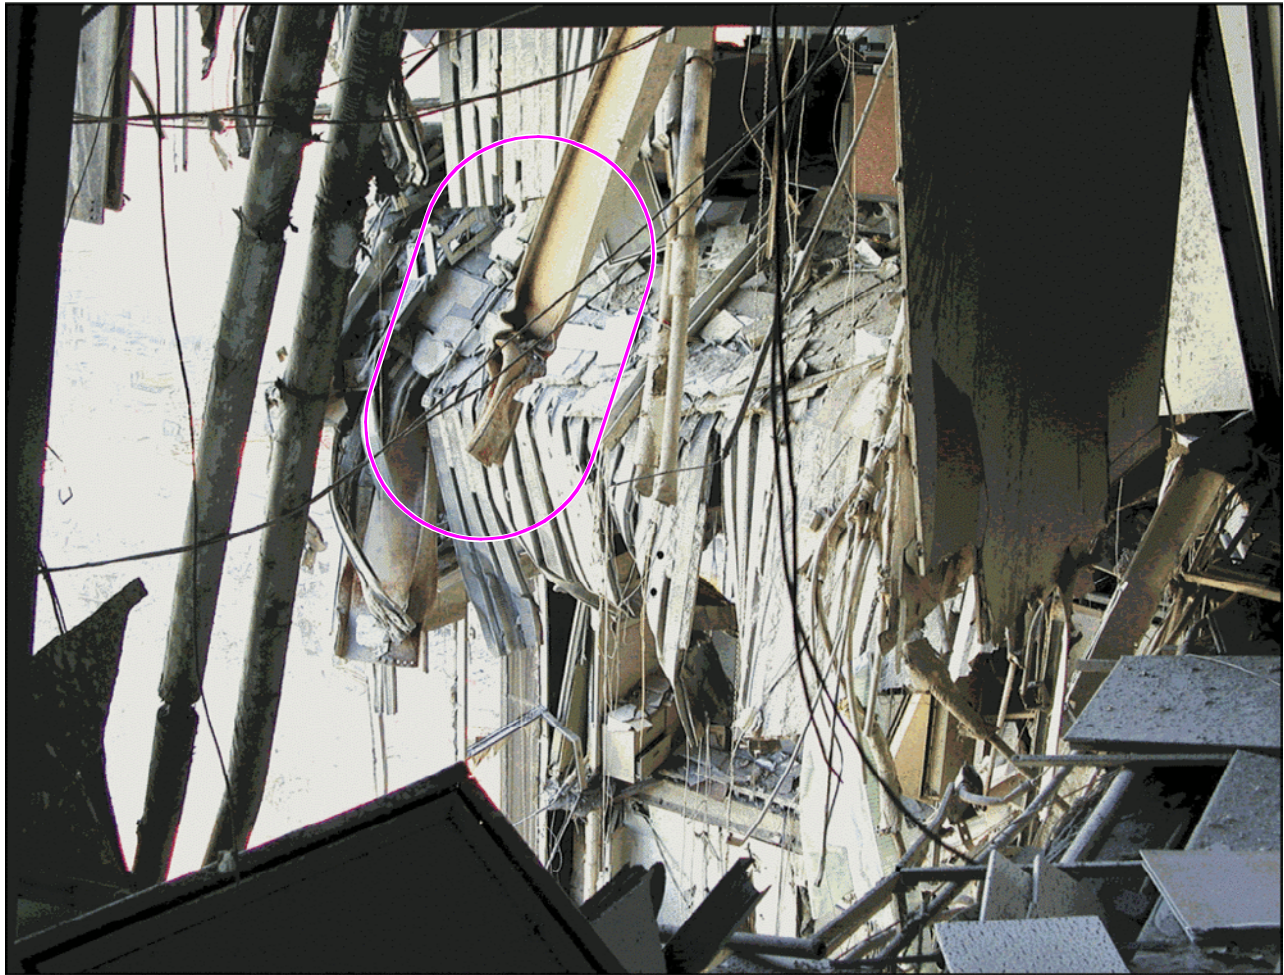
Figure 6-10 Area of collapsed floor slab in bays between C-8, E-8, C-7, and E-7, from the 15th floor.

**Figure 74.** (Fig6-10.) from the FEMA report . This beam shriveled up and has see-through holes in it, hanging in the gash/opening of Bankers Trust.

If the random deformation shown in Figures 74 and 76 were caused by heat, the paint would be burnt off.

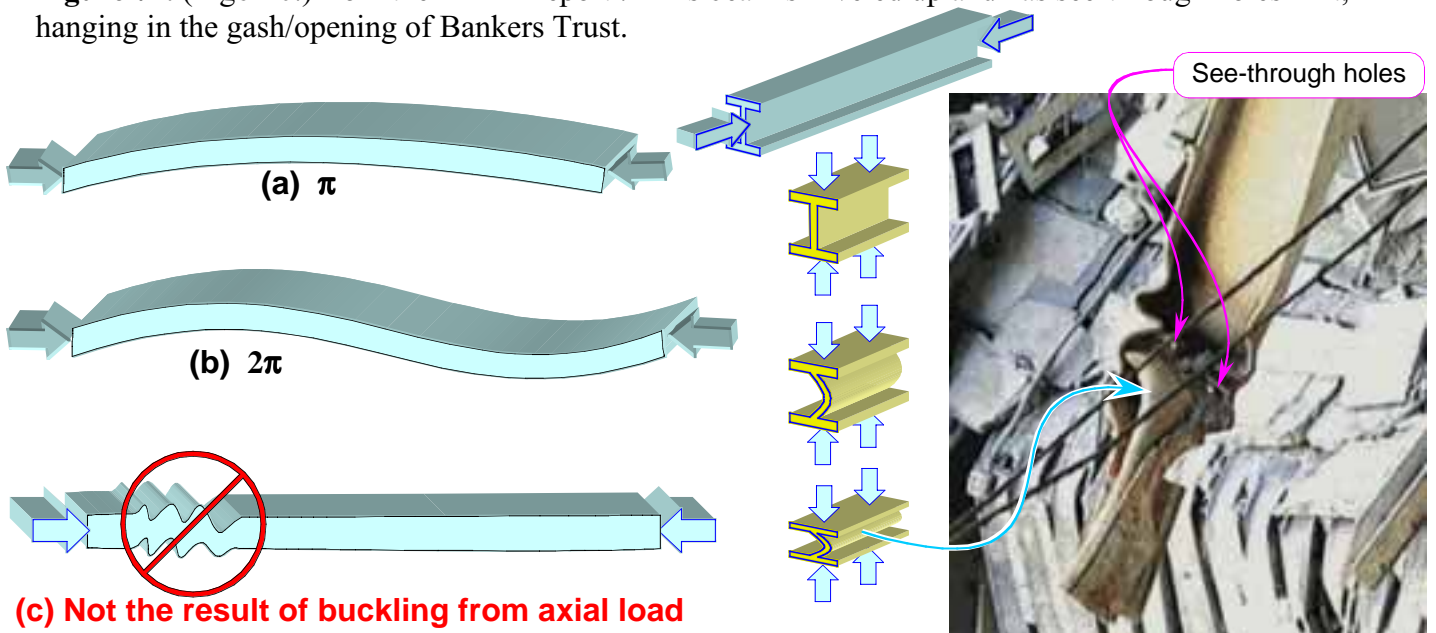
**(c) Not the result of buckling from axial load**

**Figure 75.** In buckling a beam deforms into (a) a half sine wave,  $\pi$ , or (b) a full sine wave, or  $2\pi$ . The random deformation in (c) is not associated with buckling.

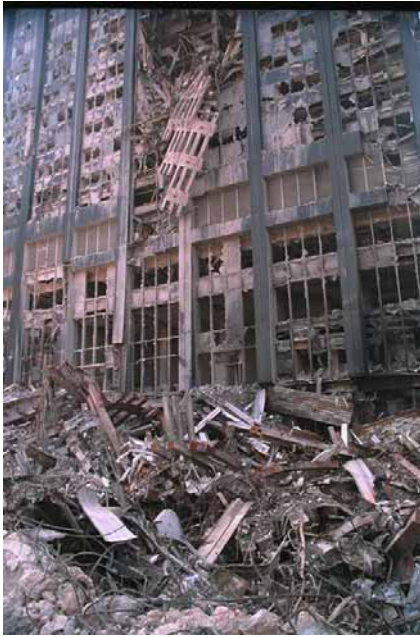
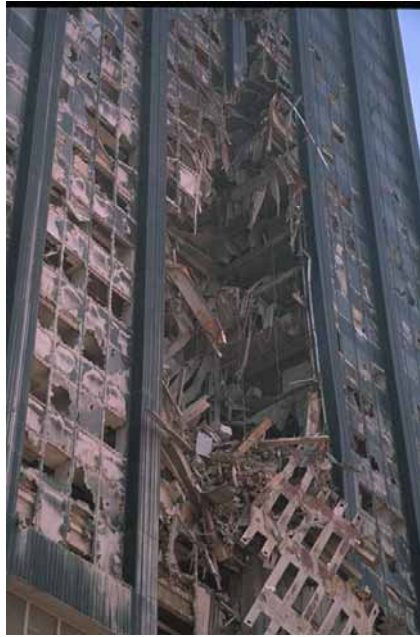
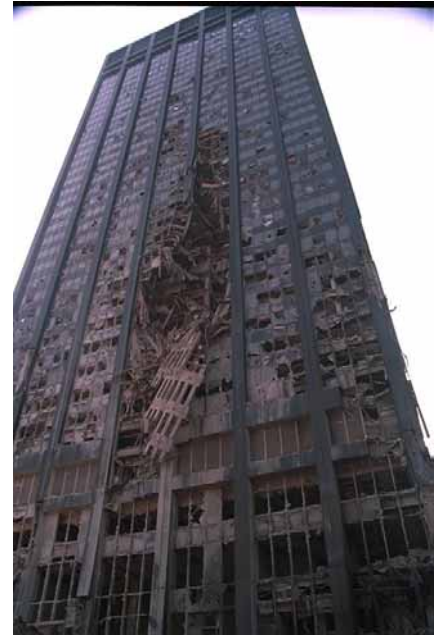
8. There is no obvious cause of the gash in Bankers Trust (BT). The wheatchex hanging from the gash did not make the gash that is several times wider and deeper and taller than the wheatchex. Also the wheatchex shows little or no apparent damage.

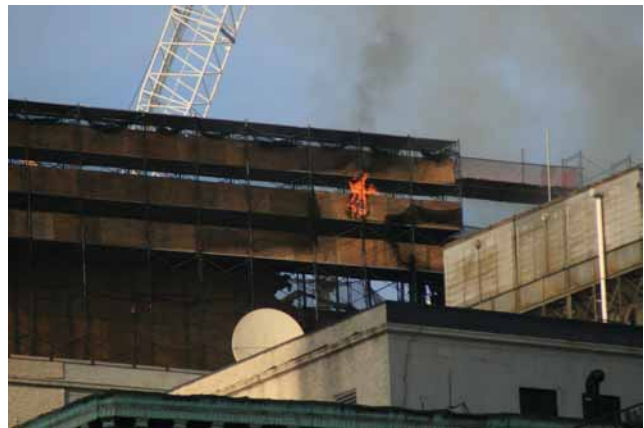
**Figure 85.** Fire at the Bankers Trust building,  
August 2007. The steel appears to be on fire  
more than the wood does. Also, there is a relative  
lack of smoke coming from those flames.  
(8/07)

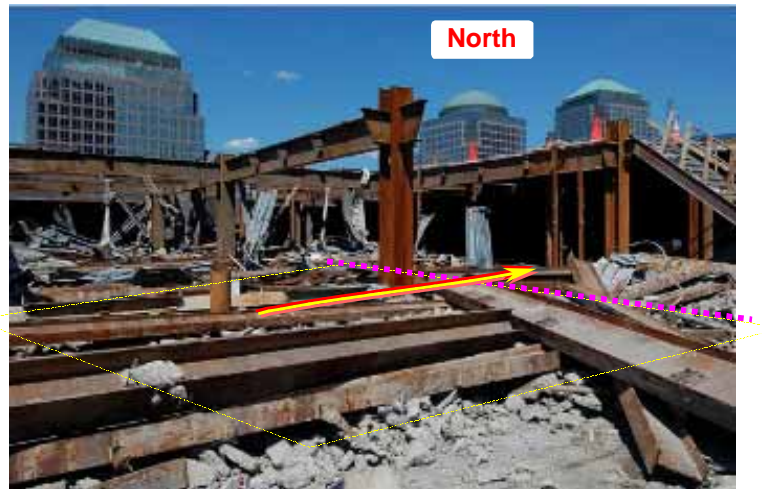
**Figure 87.** This is Bankers Trust being taken apart. Floors have been removed down to approximately the elevation shown in Figure 86. The very rusty beam (furry-rust) is approximately in the location shown in Figure 86. Recognize any "rustification" out there?

10. The rusty beam near the center of Figure 87 is incredible! How many years at the bottom of the ocean would be required to do that?

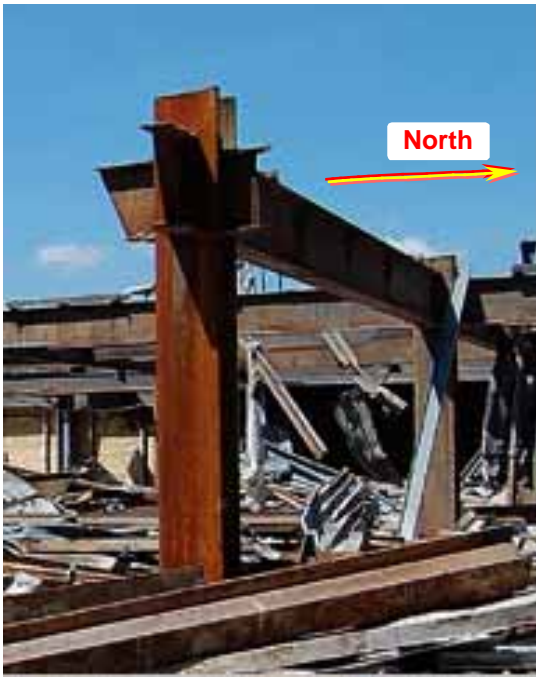
**Figure 90.** Close-up of Figure 88. As more and more beams and columns are removed, what was once an enclosed building opens up to the sky. (*brightness, contrast, adjusted*)

11. Figures 90 and 91 are in the area of where the big gash was repaired. The replacement beams were presumably new, yet they are already thick with rust as located in the diagram below.

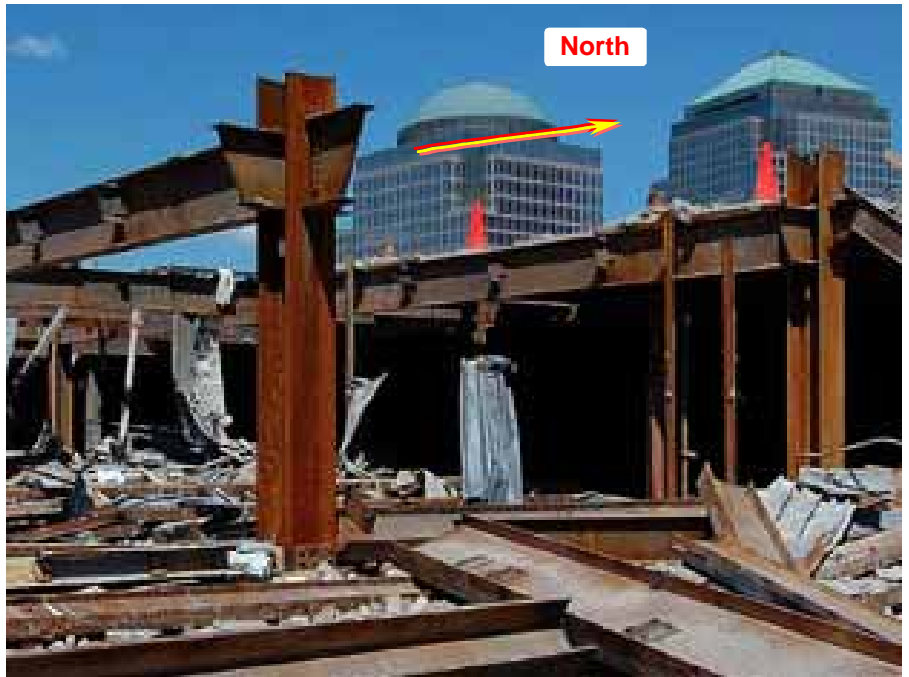
**Figure 91.** Close-up of Figure 87. This is Bankers Trust being taken apart. Recognize any "rustification" out there? (*brightness, contrast, adjusted*)

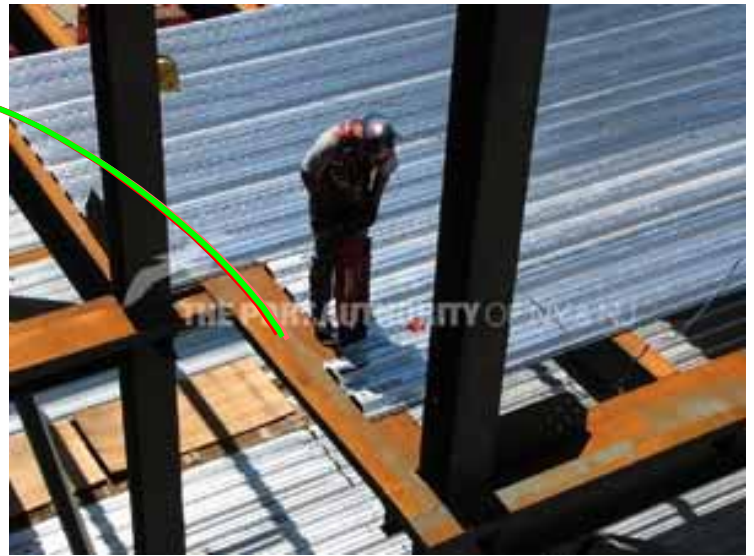
**Figure 93.** The rust forms before the beams are in place. Surfaces where beams were stacked leave silhouettes of rust. (07/07)

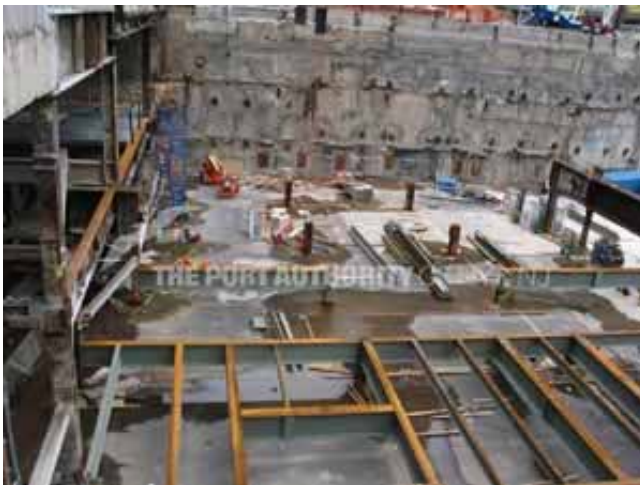
**Figure 94.** Rust appears very quickly in some areas and not others. (06/07)

13. New beams. Nearly instantaneous rust. This is not normal, especially for treated and painted beams of structural steel. This is the kind of rust you might expect to see in an iron skillet left in standing water.

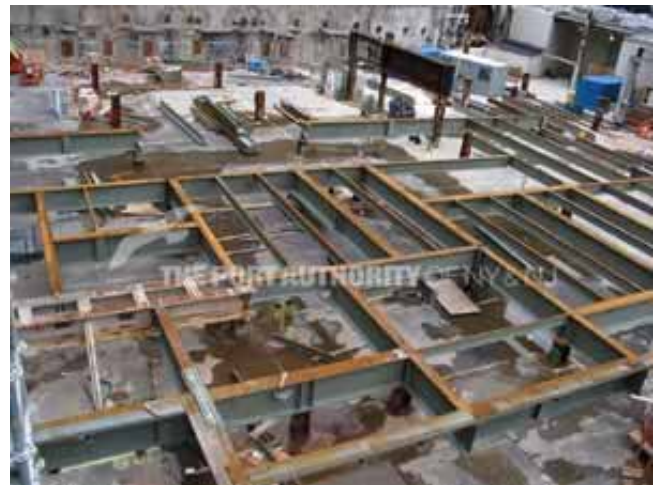
**Figure 95.** Rust appears very quickly in some areas and not others. (06/07)

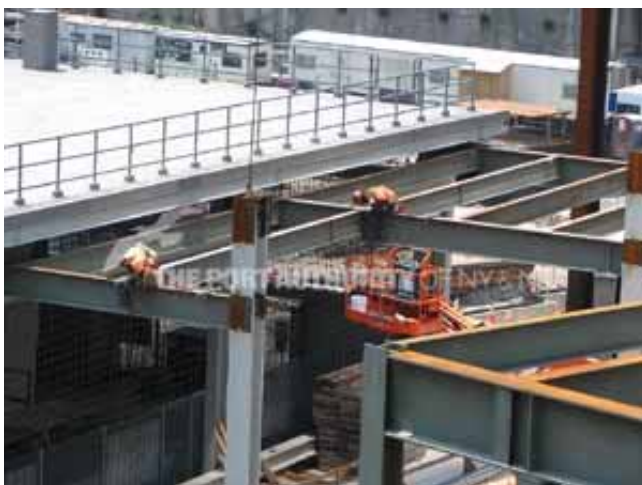
**Figure 96.** Beams rust before they are put in place.  
(06/07)

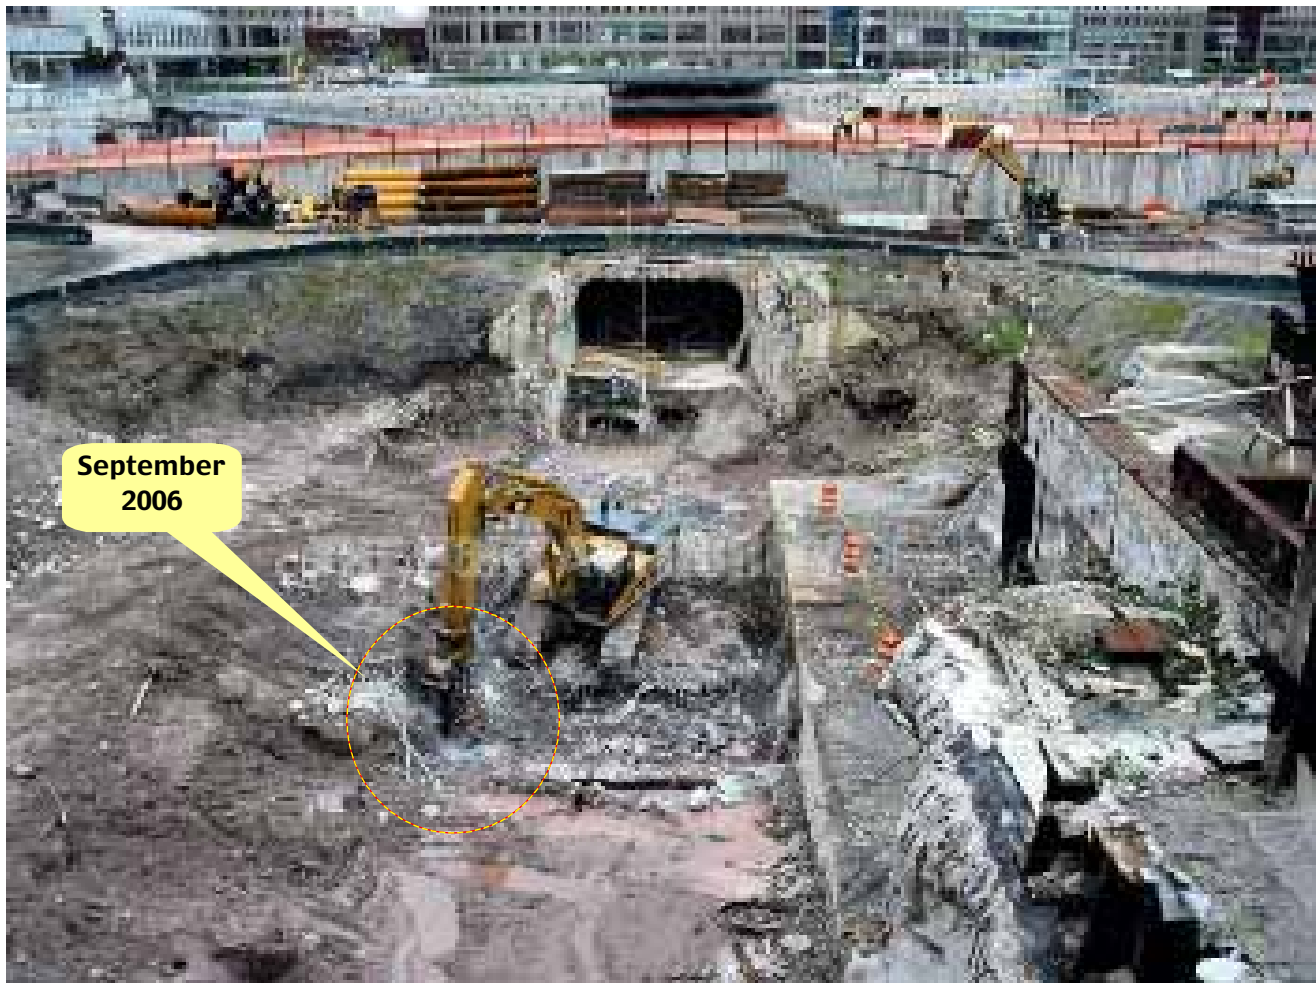
**Figure 100.** A view west along where the PATH train tracks were. Stirring the mud triggers fuming five years after 9/11. The fuming emerges from saturated dirt/mud.  
(9/06)

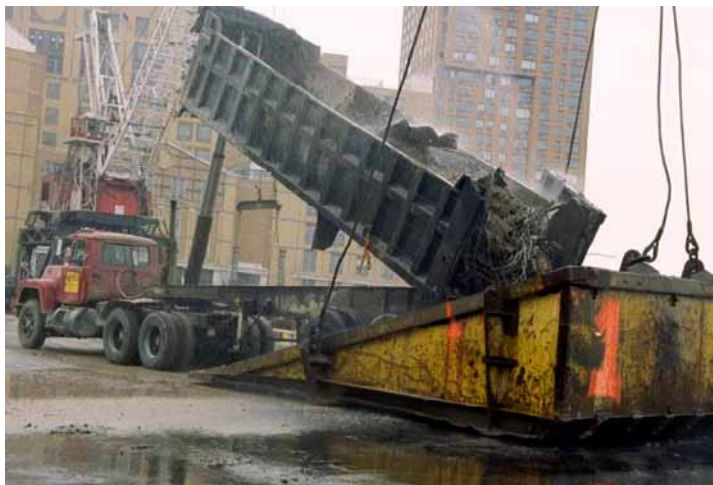
**Figure 101.** March 15, 2002, a truck dumps fuming dirt into the bucket of a 500-ton floating crane located at FEMA's Pier 25 loading site, a few blocks north of Ground Zero. The fuming dirt is sprayed with water.  
(3/15/02)

14. They officially said all fires were out at the 99-day mark. Figure **101** is at the 6-month mark, yet the truckbed and tailgate are fuming. The stuff is covered with wet dirt. They are hosing it down as they dump it -- and it is still fuming. The tailgate of the truck bed is swung open and is fuming with no water on it. The water appears to cut down on the fuming. If this were steam, we would see the opposite of this.

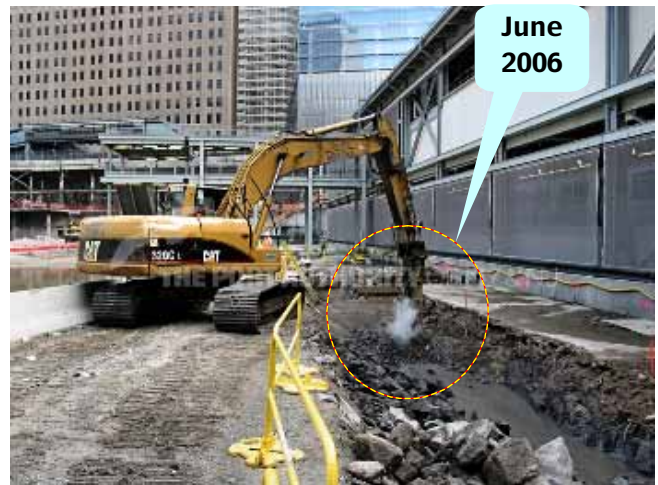
**Figure 102.** June 2006, looking north in the big bathtub. The new WTC7 is in the distance, on the right. Here's why the dirt is needed. This is the same "puff-ball poofing" I saw in October!  
(6/06)

16. In Figure **102** the power shovel is stirring up the fuming in a mud puddle nearly five years after 9/11.
